ST0791/4

A serviceability level racking test on a Rockcote AAC panel wall cavity system

Author: Stuart Thurston
Senior Structural Engineer

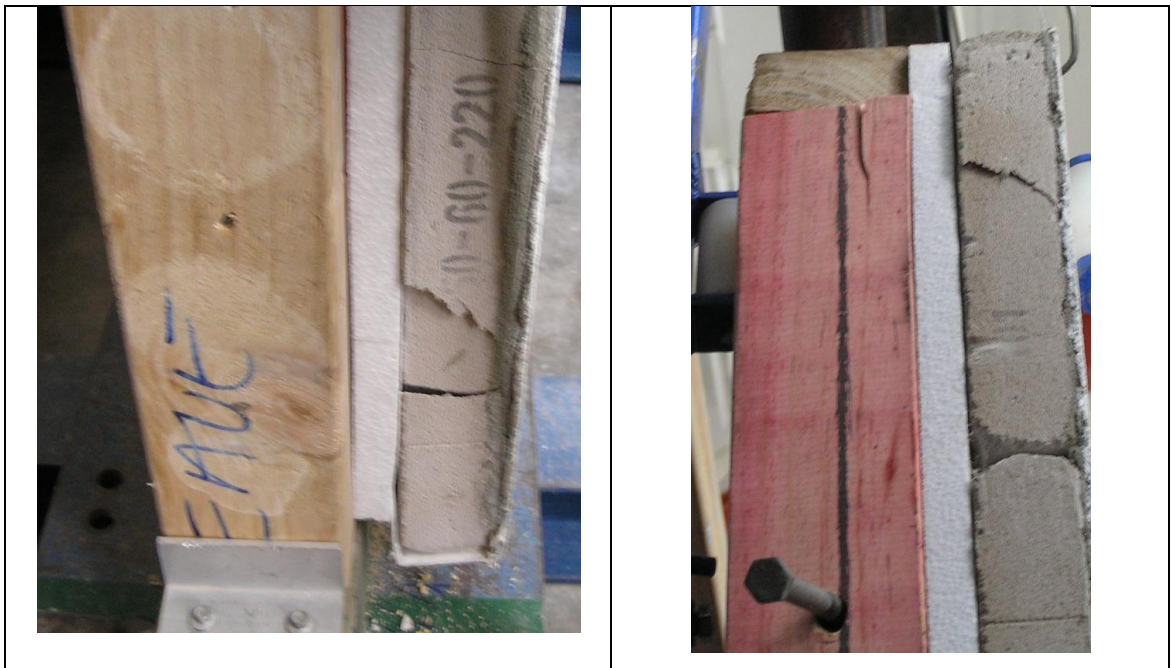
During the ± 16 mm cycling a single fine crack near both the top and bottom of the wall could be seen in the AAC panels at both wall ends (i.e., four cracks in total) (see Figure 3 and 4). Some differential vertical movement was observed between the frame and battens and between the battens and panels. The top plate was slipping significantly relative to the panels.

Figure 3. Bottom and top of panel south end after ± 16 mm cycling

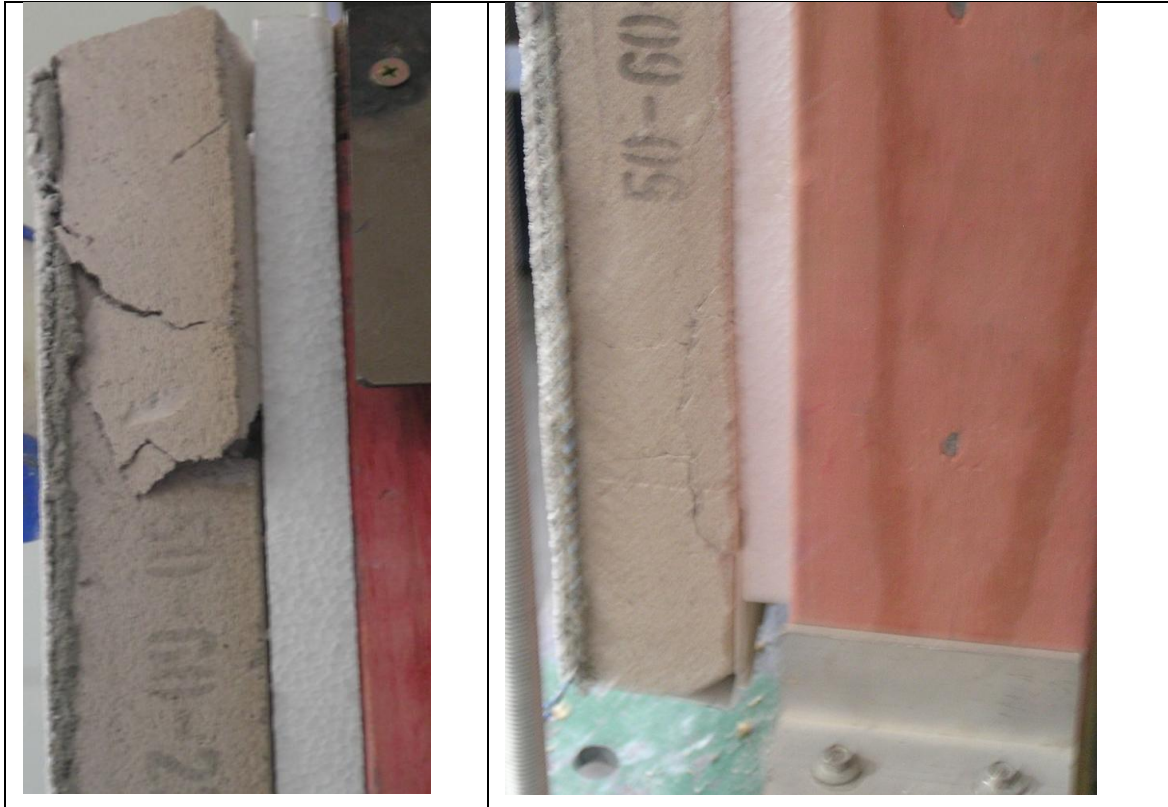
Figure 4. Top and bottom of panel north end after ± 16 mm cycling

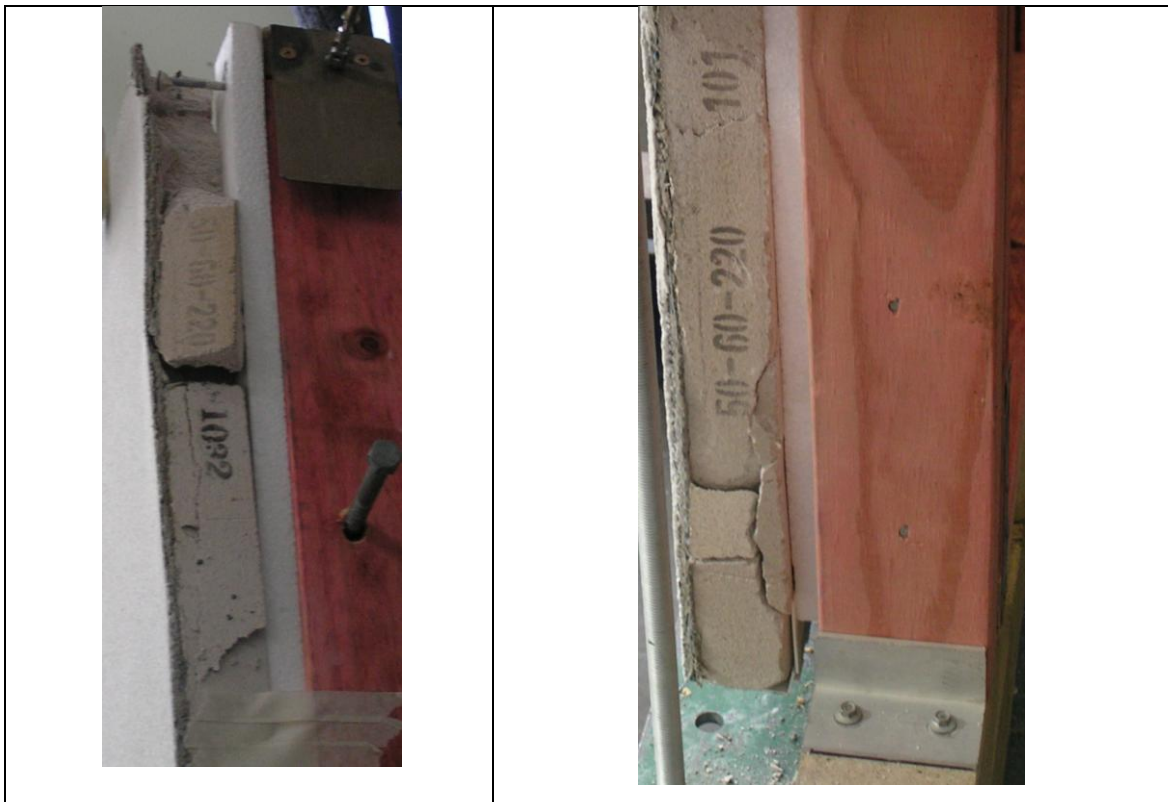
During the ± 36 mm cycling the damage and slippage noted at ± 16 mm cycling was accentuated. The wall studs lifted slightly from the bottom plate. The top plate was slipping on the end studs.

Figure 5. Top and bottom of panel north end after ± 36 mm cycling

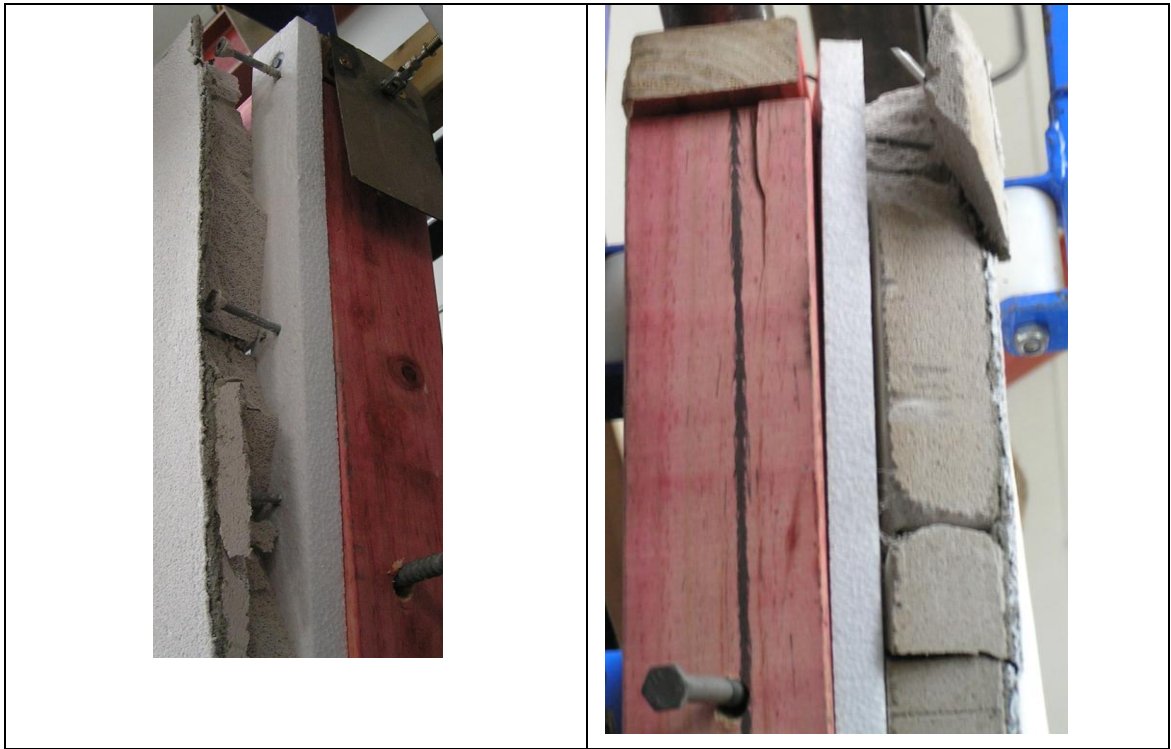
During the ± 55 mm cycling 75% of the applied deflection was being taken up by slippage of the top plate relative to the cladding although there was little increase in differential movement frame-to-battens and battens-to-panels. It was noted that some

screws from the cladding to the top plate were largely ineffective as they were located near the junction of the stud to the top plate. Portions of the panels were spalling at the ends at the top of the wall.

Figure 6. Top of panels at both ends after ± 55 mm cycling
