# STRUCTURES TEST REPORT

## ST10322-001

**A SERVICEABILITY LEVEL RACKING TEST ON A  
ROCKCOTE RESENE LTD AAC PANEL WALL CAVITY  
SYSTEM**

**ST10322-001**

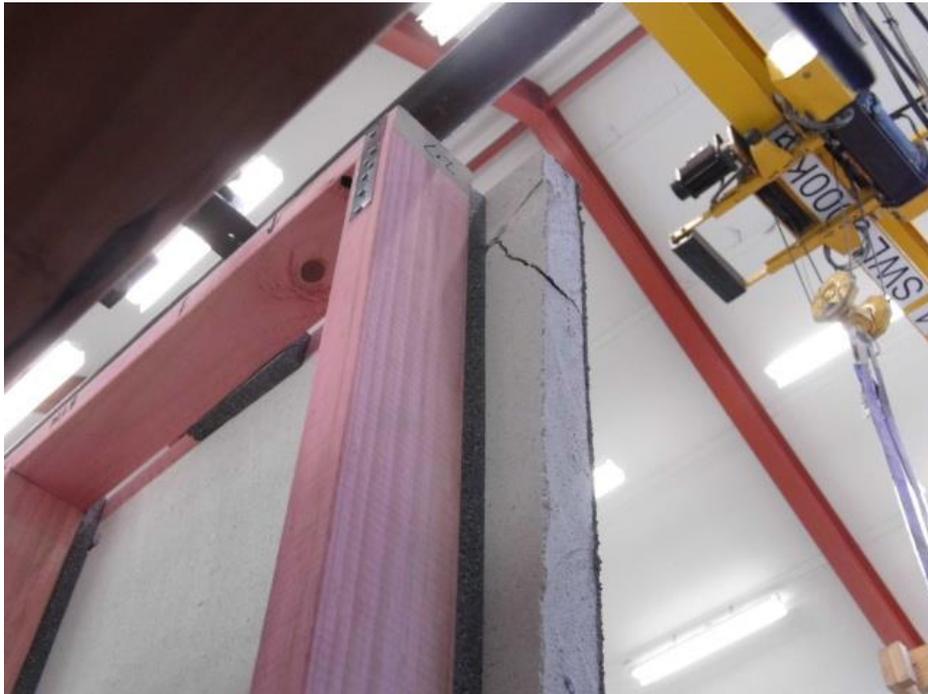
While displacing towards + 62 mm, when the displacement reached 45mm the top corner of the top panel at one end of the specimen cracked and then broke at + 62 mm (Photo 5). In the reversing direction to - 62 mm, the top corner at the other end of the specimen broke off (Photo 6).

**Photo 5: Crack at the top corner during the + 62 mm cycle**

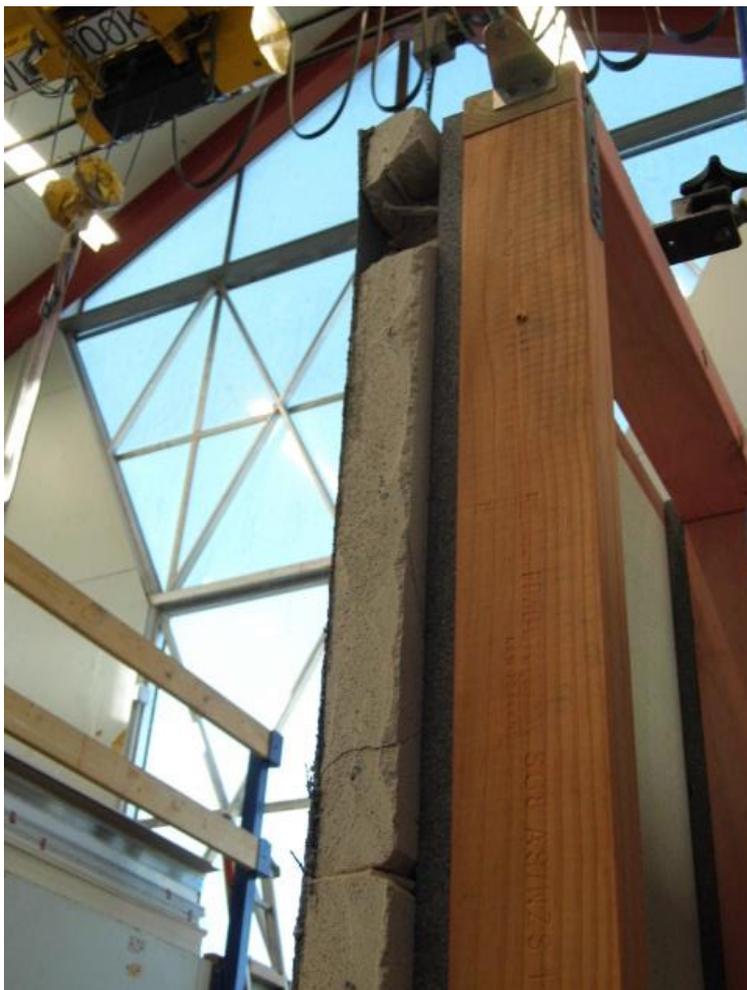
**Photo 6: Broken off piece of panel during the - 62 mm cycle**
