ST0791/3

A face load test on a Rockcote AAC panel wall cavity system

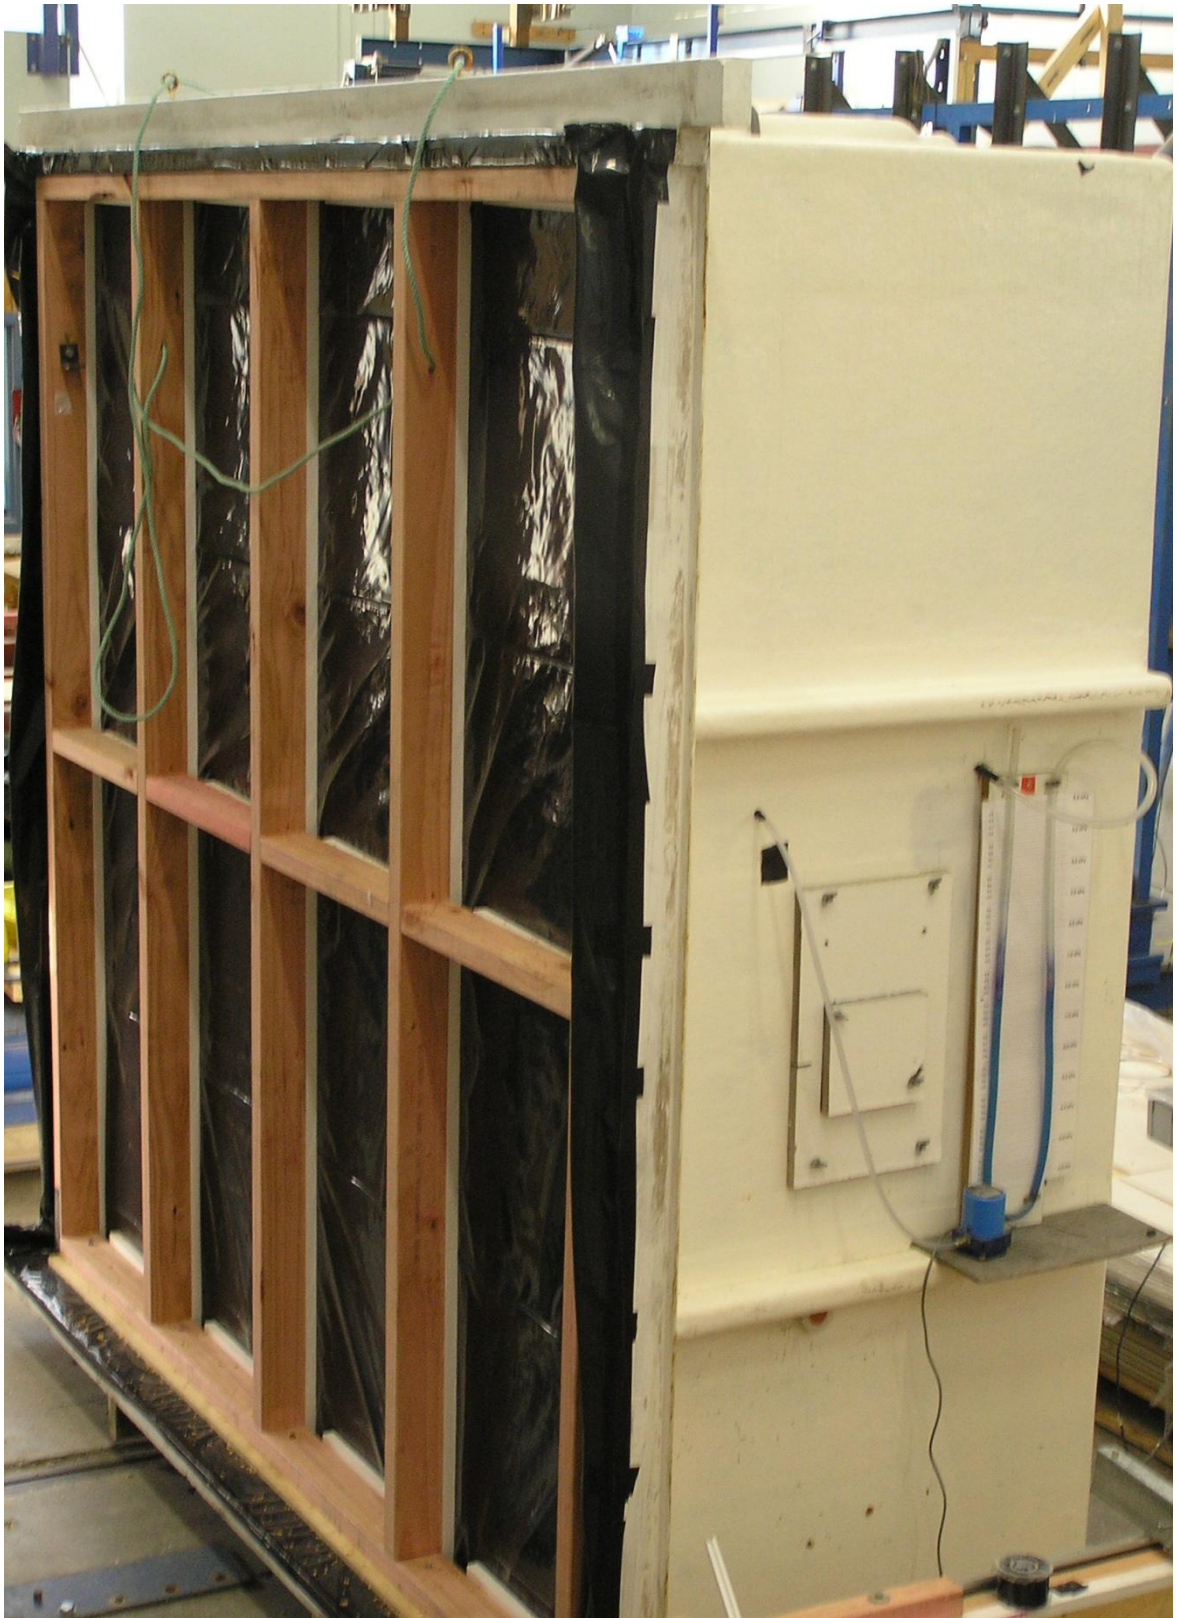
Figure 1. Specimen in the test chamber

A test specimen of nominal size 2.4 m x 2.4 m was constructed by the client at BRANZ. The specimen size was selected to fit in the opening in the laboratory pressure chamber as shown in Figure 1. Studs were at nominal 600 mm centres and nogs at 1200 mm centres. All framing timber was 90 x 45 grade MSG 8 Radiata Pine assembled using normal trade practice. Full height polystyrene battens, of cross section 50 x 20 mm, were fixed to the front face of the studs to leave a 20 mm air-gap between studs and panels. Short lengths of these battens were also used between studs on the front face of top and bottom plates and nogs. General photographs of construction and installation of the specimen into the pressure chamber and shown in Figures 1 to 3.

The specimen was secured in an upright position within the front opening of an airtight pressure chamber with the plastered face inside. The top and bottom plates were securely fixed directly to the perimeter of the chamber with Tek screws. A layer of 250 µm polythene film was placed between the timber battens and the lightweight panels at the time of the specimen construction to achieve air tightness. The sides of each specimen were not fixed, but were sealed all around using the polythene sheet and adhesive tape so that the studs of the test wall could deflect without restraint from the side of the chamber.

The specimen was tested under negative pressure applied to the chamber shown in Figure 1 corresponding to "suction" on a building. The pressure was applied in increasing steps of 0.1 kPa. Each pressure step was held for one minute. The pressure was then released back to zero for 15 seconds before the next level of pressure was applied to the specimen. This test procedure is based on AS 4040.2:1992[2].

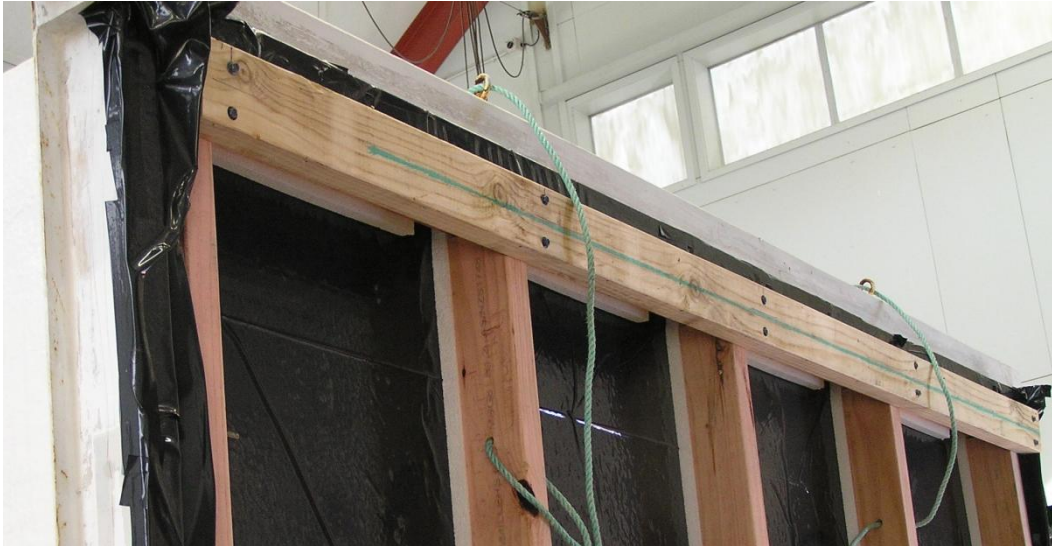
Figure 5. Detail of strong-backs at the top

At 3.6 kPa the studs had sheared 20 mm on the top plate. To help preclude failure here and at the bottom of the specimen, a strong-back was installed at both top and bottom stud/plate junctions. In addition a strong-back was installed at wall mid-height to help share the load between studs should one stud be weaker than the others. Photographs of these strong backs are shown in Figures 4 to 5.

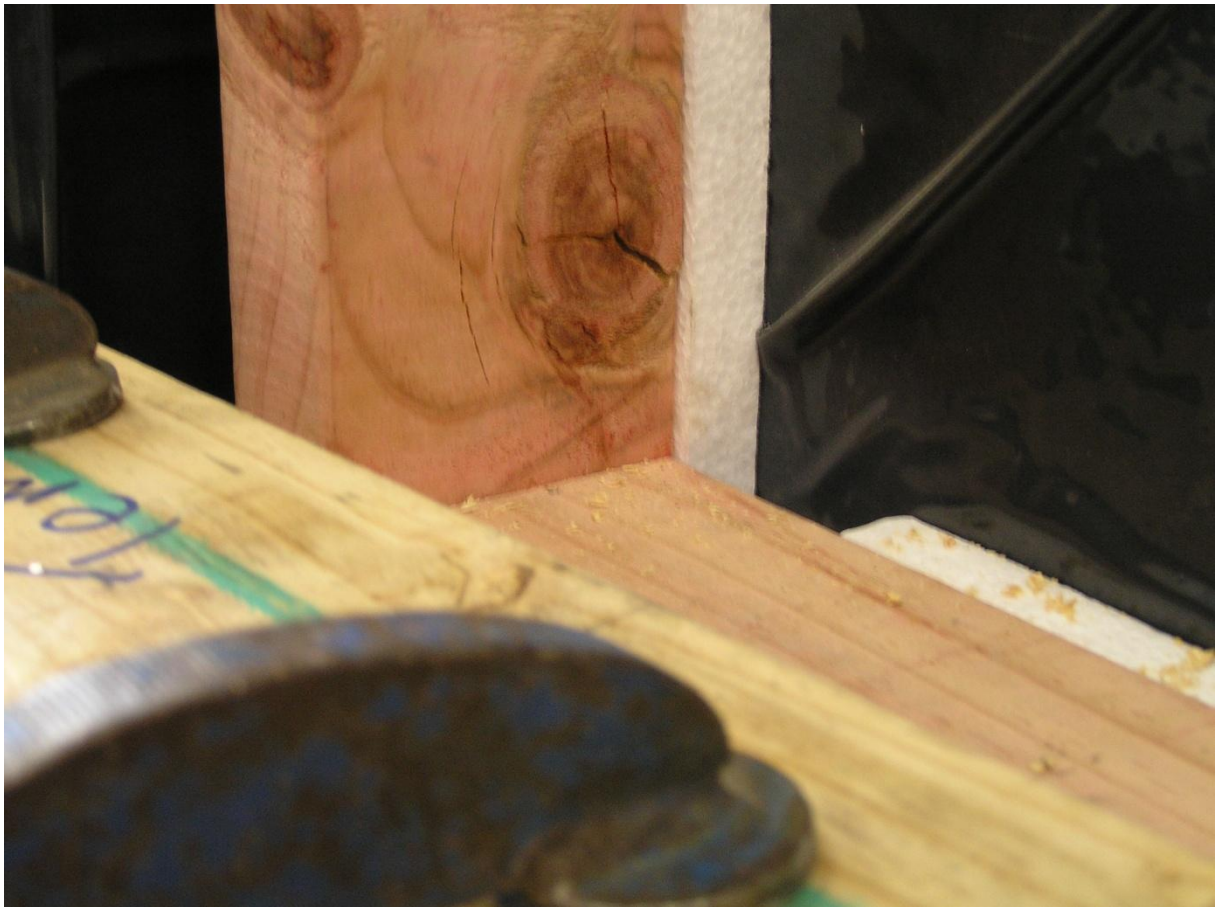
Figure 6. Stud cracking at a knot at 5.5 kPa and stiffening piece G-clamped to strong-back

At 5.5 kPa one end stud had cracked at a knot as shown in Figure 6. The strongback was extended at this location so that the stud loading was partially resisted by the edge of the pressure box as shown in Figure 6.

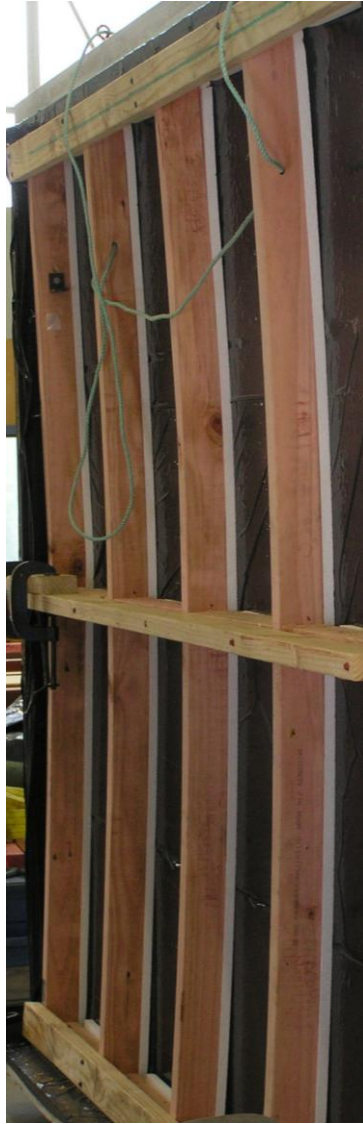
Figure 7. Stud bending at 6.0 kPa
