FIRE TEST REPORT

FR6289-01-2

FIRE RESISTANCE TEST OF A RESENE CONSTRUCTION LOAD-BEARING INTER-TENANCY WALL SYSTEM

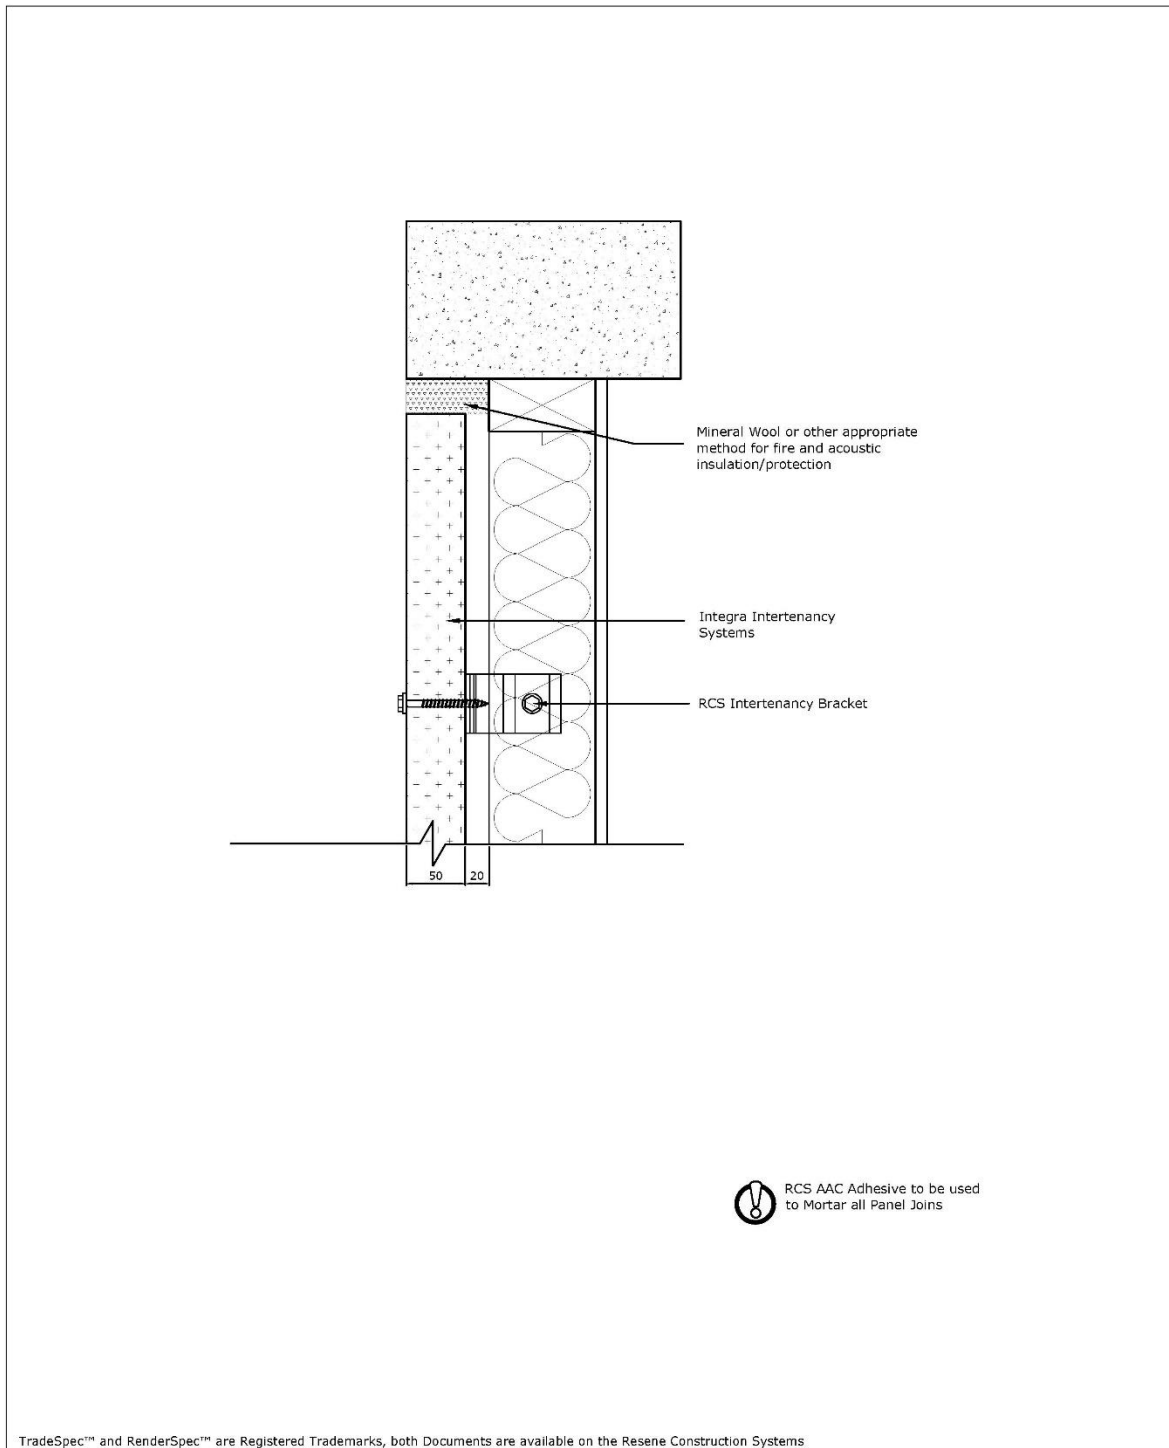
Figure 1: Cross Section Drawing of Wall

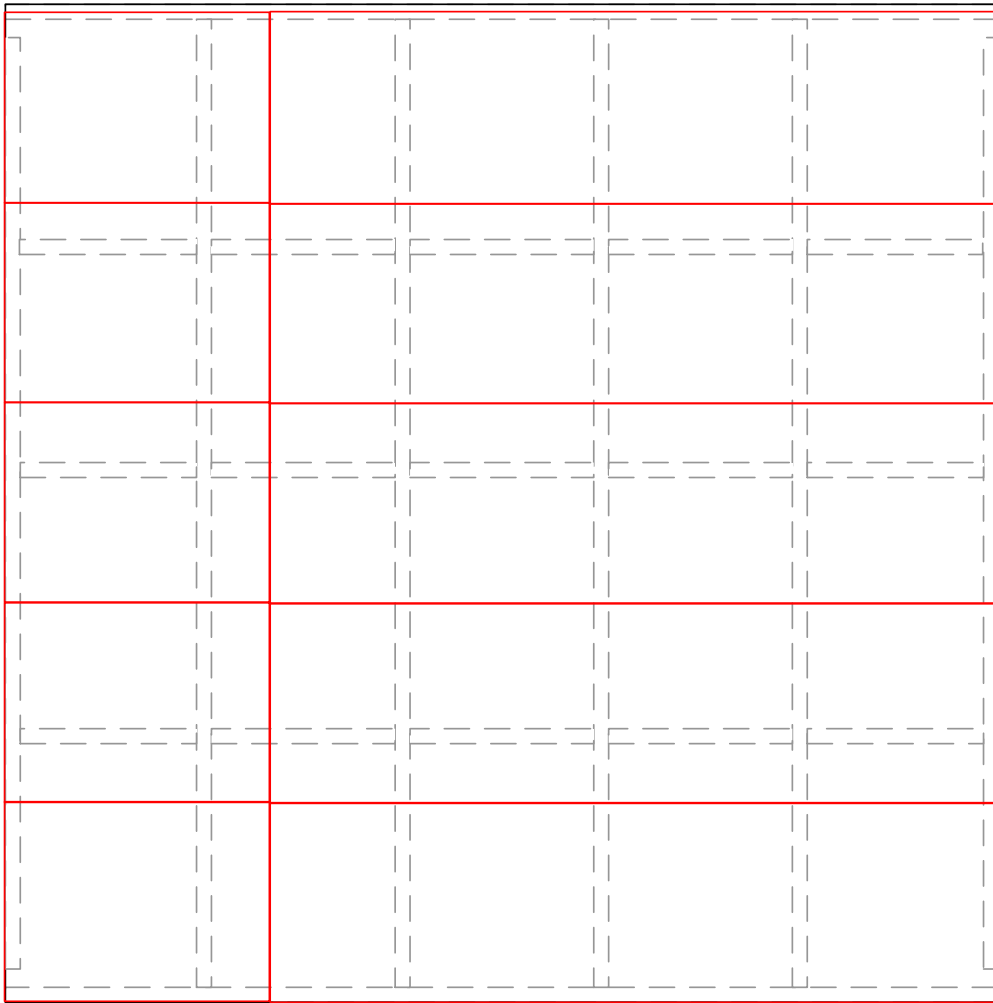
Figure 2: Elevation of the Wall, Viewed from the Exposed Side

Integra AAC panel boundaries

centres, between the studs, as shown in Figure 2. No sample was provided to determine the moisture content of the framing. There was no indication of excess moisture present.

The Integra AAC panels were 2,200 mm long by 600 mm high by 50 mm thick. The panels were installed horizontally as shown in Figure 2.

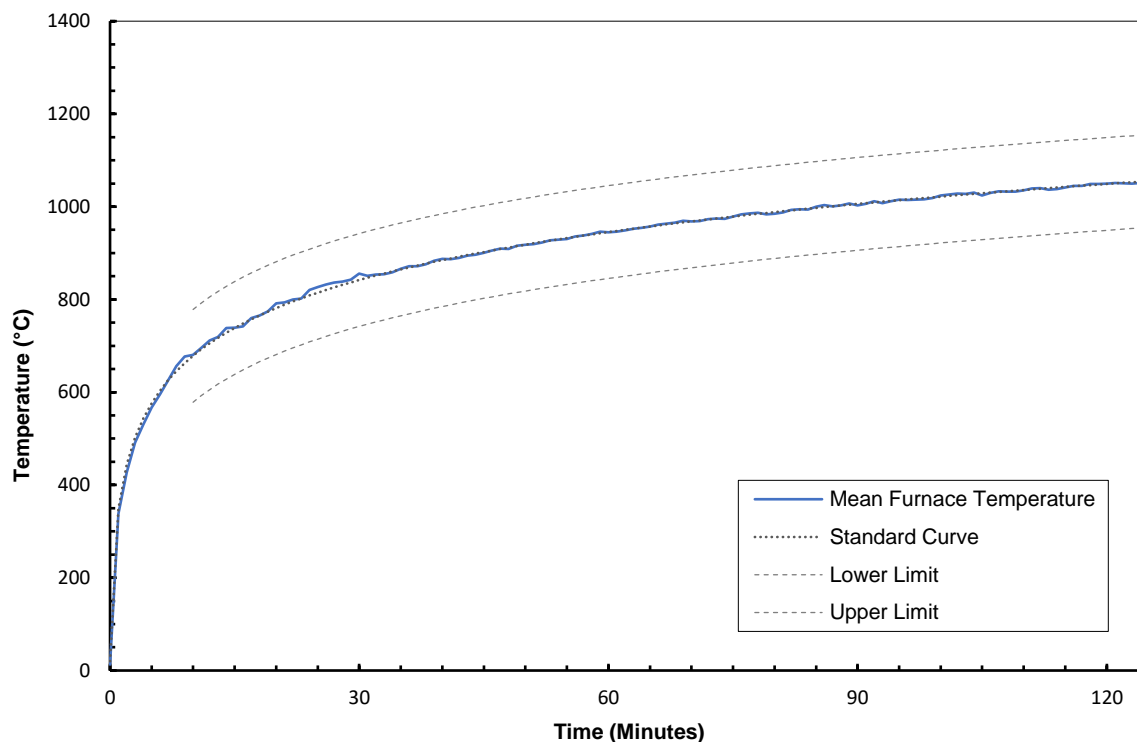
Figure 3: Furnace Temperature

Figure 3 shows the furnace temperature curve and the permitted upper and lower limits in accordance with AS 1530.4:2014.

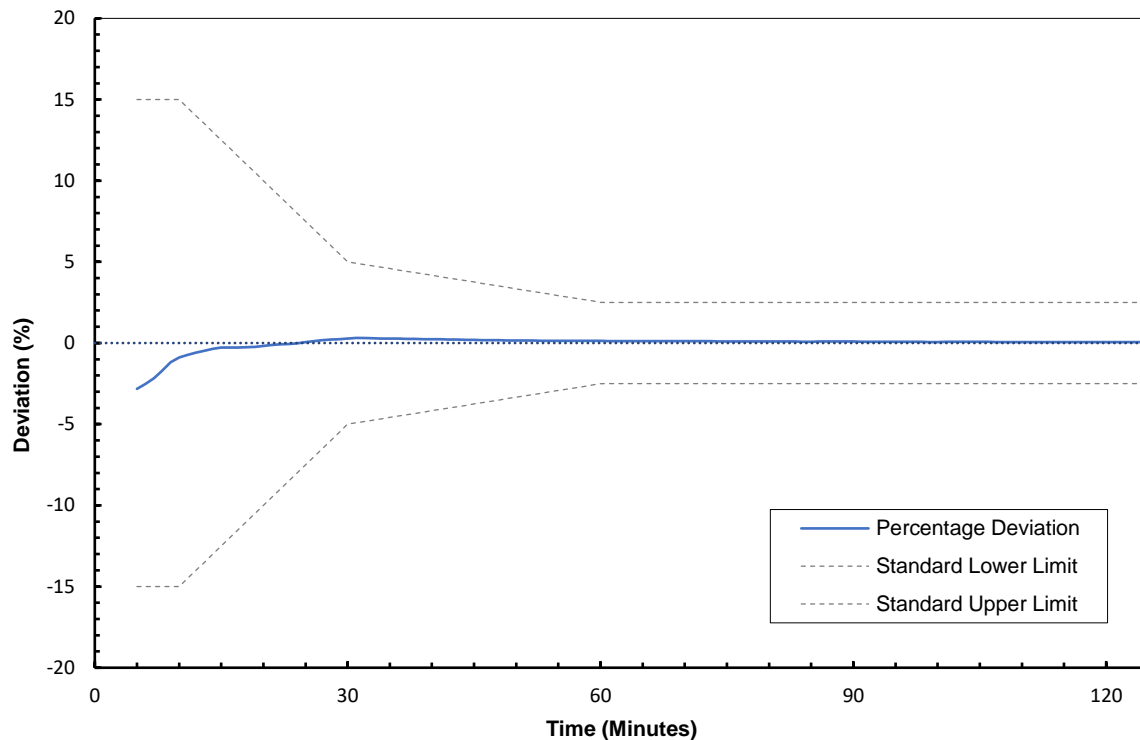
Figure 4: Percentage Deviation from Standard Curve

Figure 4 shows the percentage deviation of the mean furnace temperature from the Standard curve.

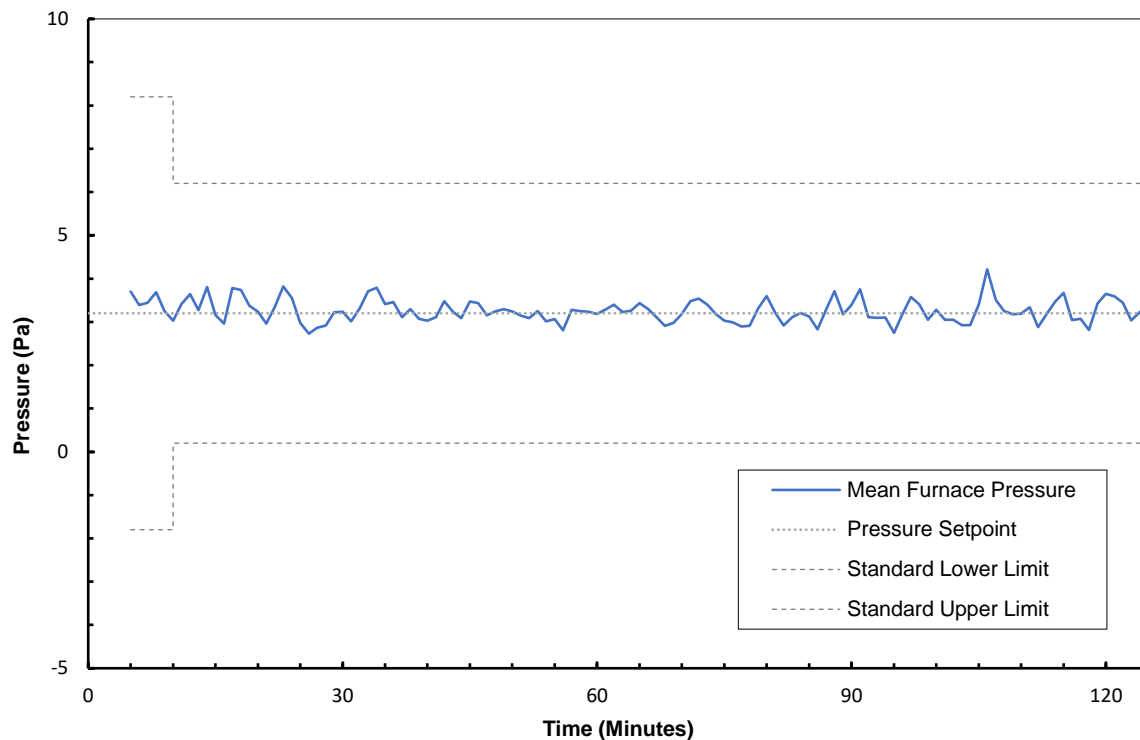
Figure 5: Furnace Pressure

The furnace pressure met the requirements of the standard for the duration of the 125 minute test.

The differential pressure of the furnace above the laboratory atmosphere was controlled to be 0 Pa at 500 mm above the notional floor which corresponds to 3.2 Pa at the pressure probe in the furnace. The differential pressure was monitored using a micromanometer connected to a computer controlled data logging system which recorded the pressure at 15 second intervals. Figure 5 shows the furnace pressure variation with time.

The pressure was set based on the wall test criteria, not the service penetrations, which would have required the pressure to be 15 Pa at 310 mm above the notional floor of the furnace (halfway up the lowest penetration).

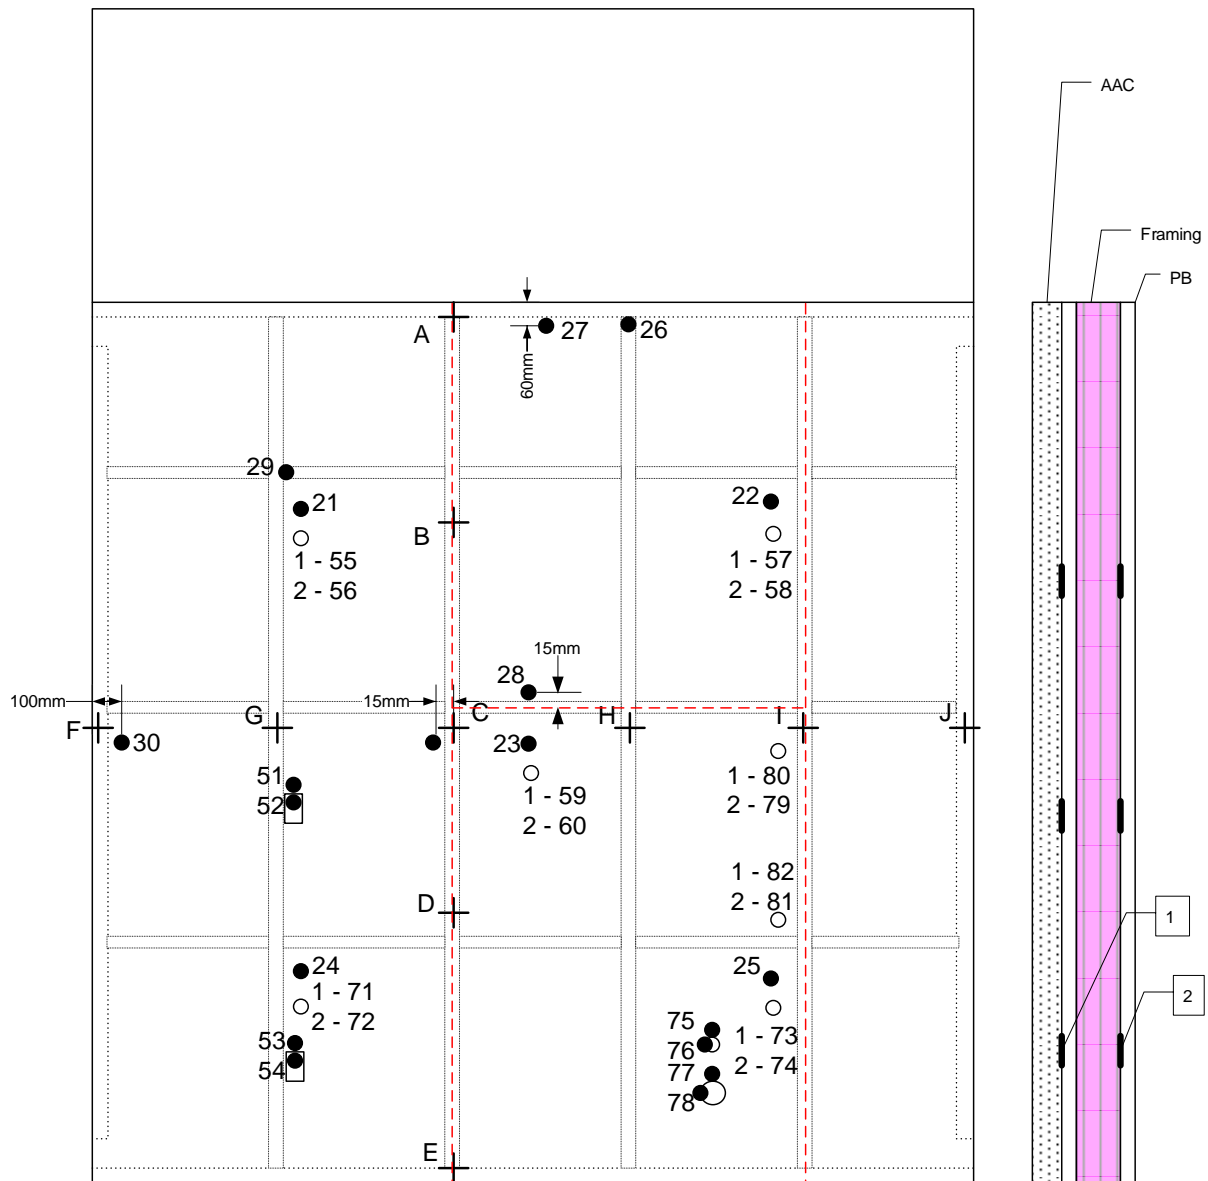
Figure 6: Thermocouple Locations and Deflection Points

- + Deflection points
- Internal T/C
- Unexposed face T/C

The temperature on the unexposed face of the test specimen was measured using chromel-alumel thermocouples mounted on copper discs and covered with insulating pads, in accordance with clause 2.2.3 of the test standard. The thermocouples were placed on the wall as shown in Figure 6.

The lateral deflections on the unexposed face at the positions shown in Figure 6 were measured using a theodolite and rule. The top plate of the wall was bolted directly to the concrete infill panel at the top of the test frame, with M16 bolts. It is considered unlikely that the frame would be able to move 12 mm towards the furnace, the readings from location A have therefore been excluded as anomalous. The maximum measured deflection was 10 mm, away from the furnace at mid height and mid width of the wall (deflection point C), at 120 minutes. The results are summarised in Table 1.

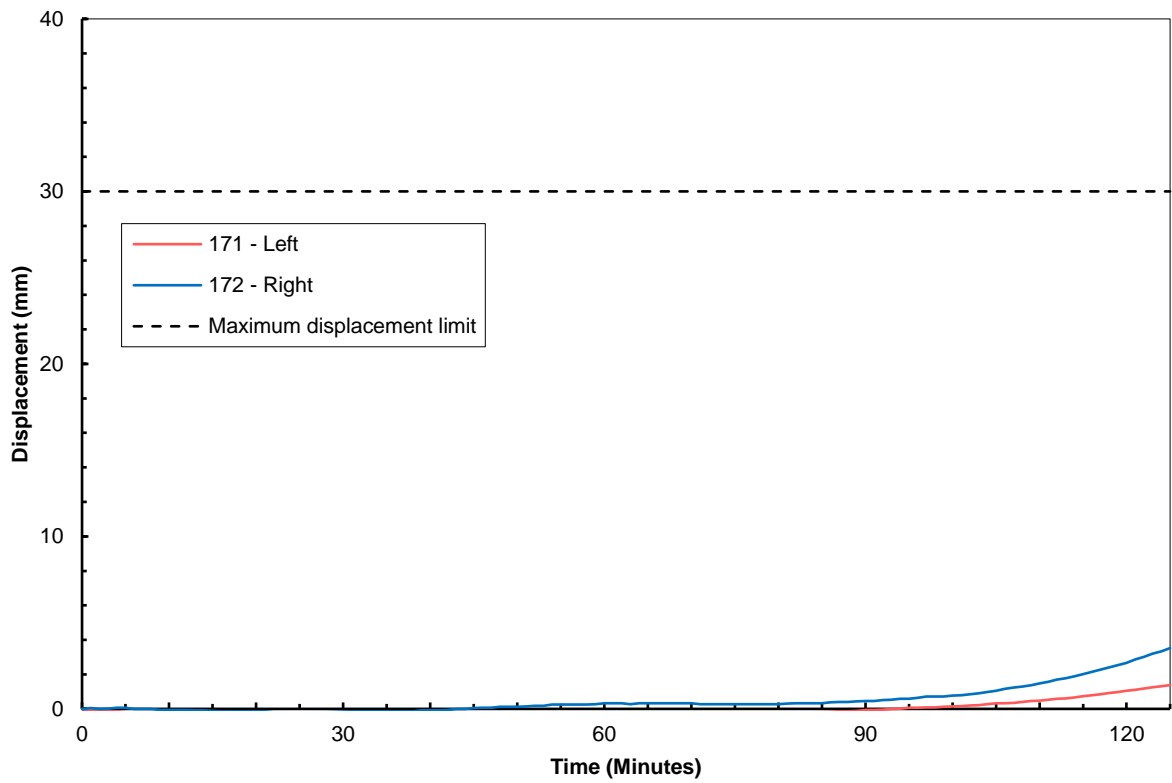
Figure 8: Axial Deflection of the Wall

Over the duration of the test, the wall experienced a net contraction. The maximum measured axial deflection of the wall was 3.5 mm, measured at the right-hand side of the specimen and occurred at 125 minutes into the test. The wall did not exceed the limiting axial deflection of 30 mm for the duration of the test. Figure 8 shows the axial deflections over the duration of the test.

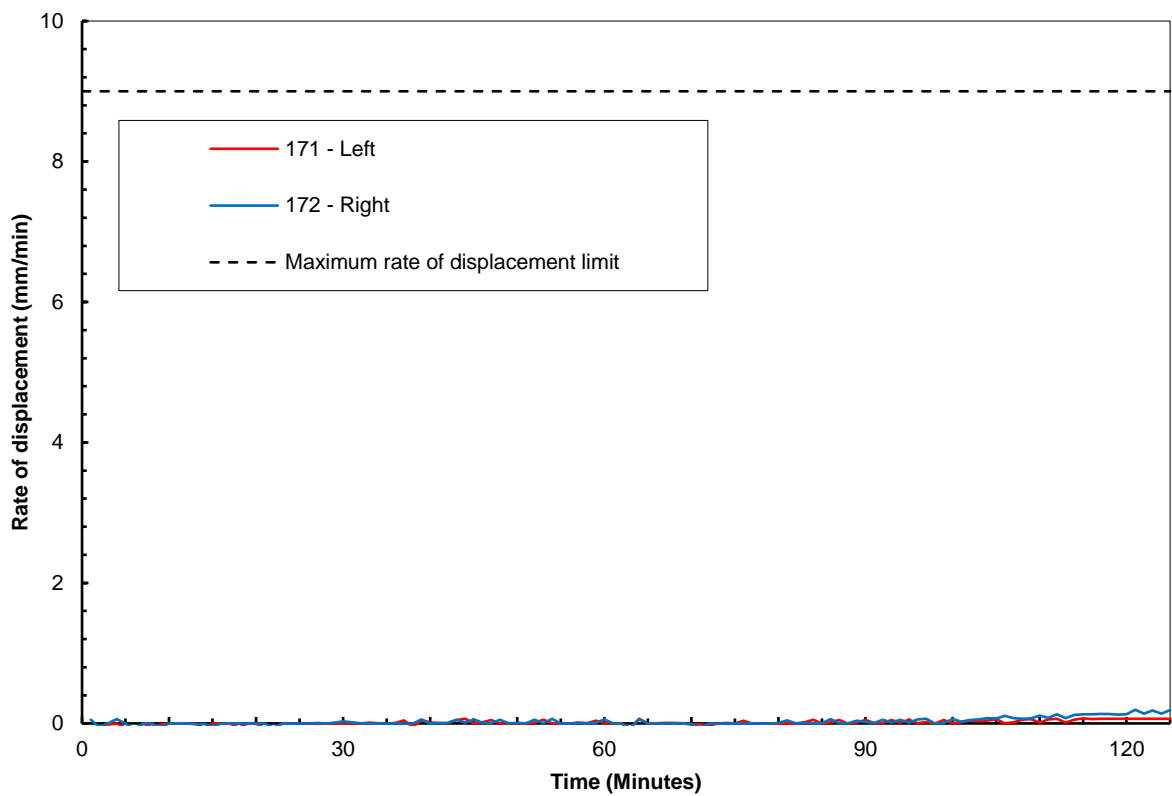
Figure 9: Rate of Axial Deflection of the Wall

The maximum measured rate of axial deflection was 0.2 mm/min and occurred at 121 minutes at the LVDT on the right-hand measuring spot. The wall did not exceed the 9 mm/min maximum allowable rate of axial deflection for the duration of the test. Figure 9 shows the rate of axial deflection over the duration of the test.

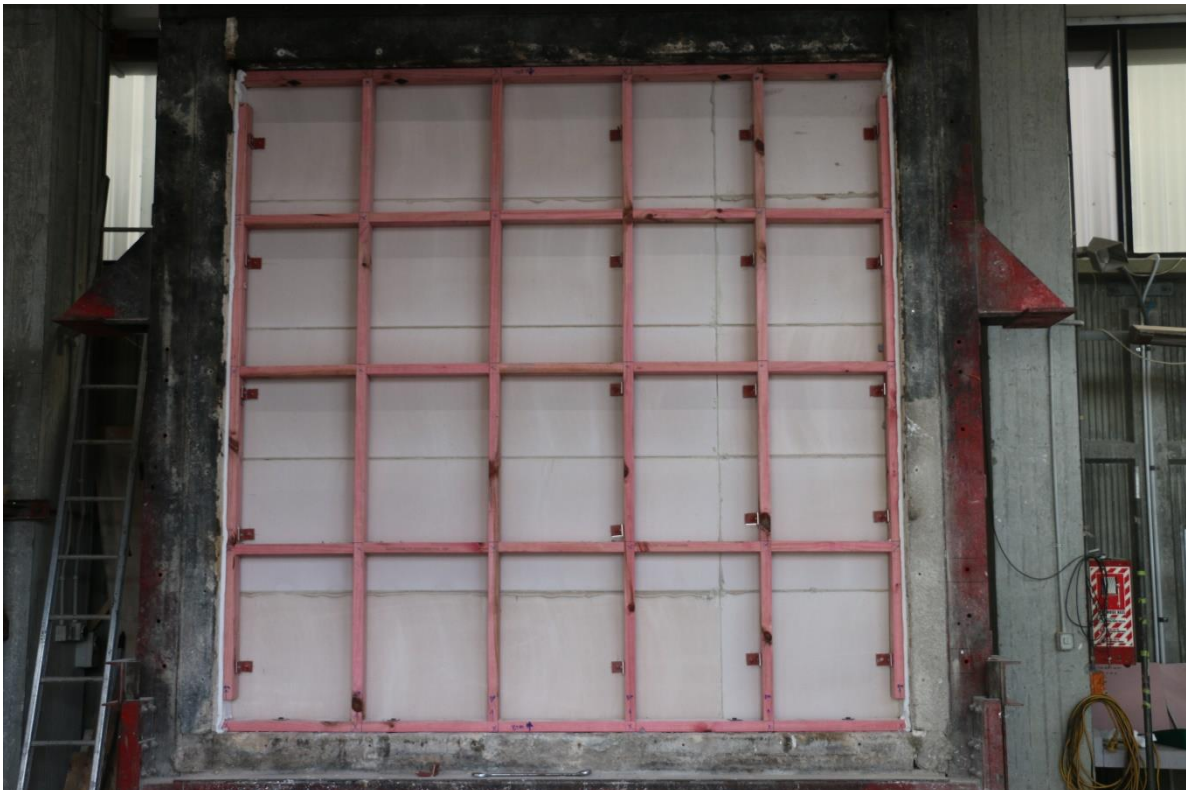
Photo 2: Unexposed Side of Panel Prior to Lining Installation

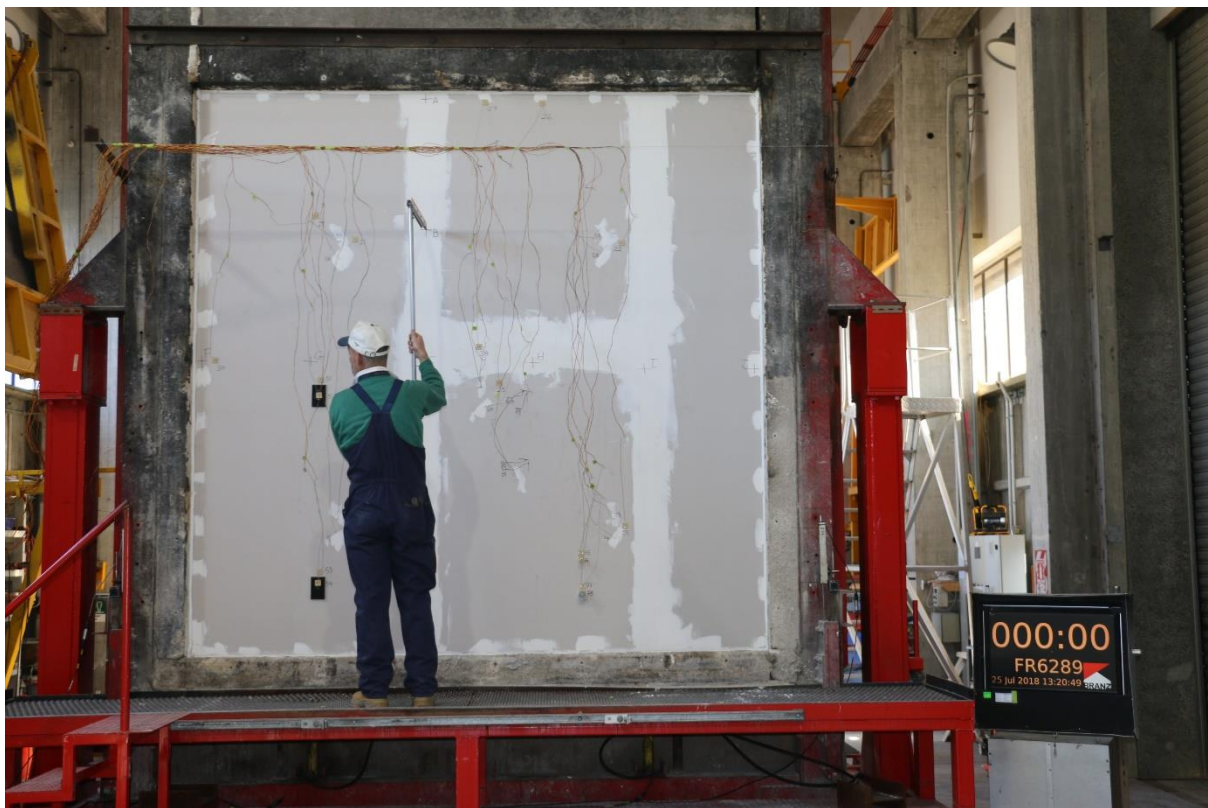
Photo 3: The Unexposed Face of the Completed Wall Before the Test

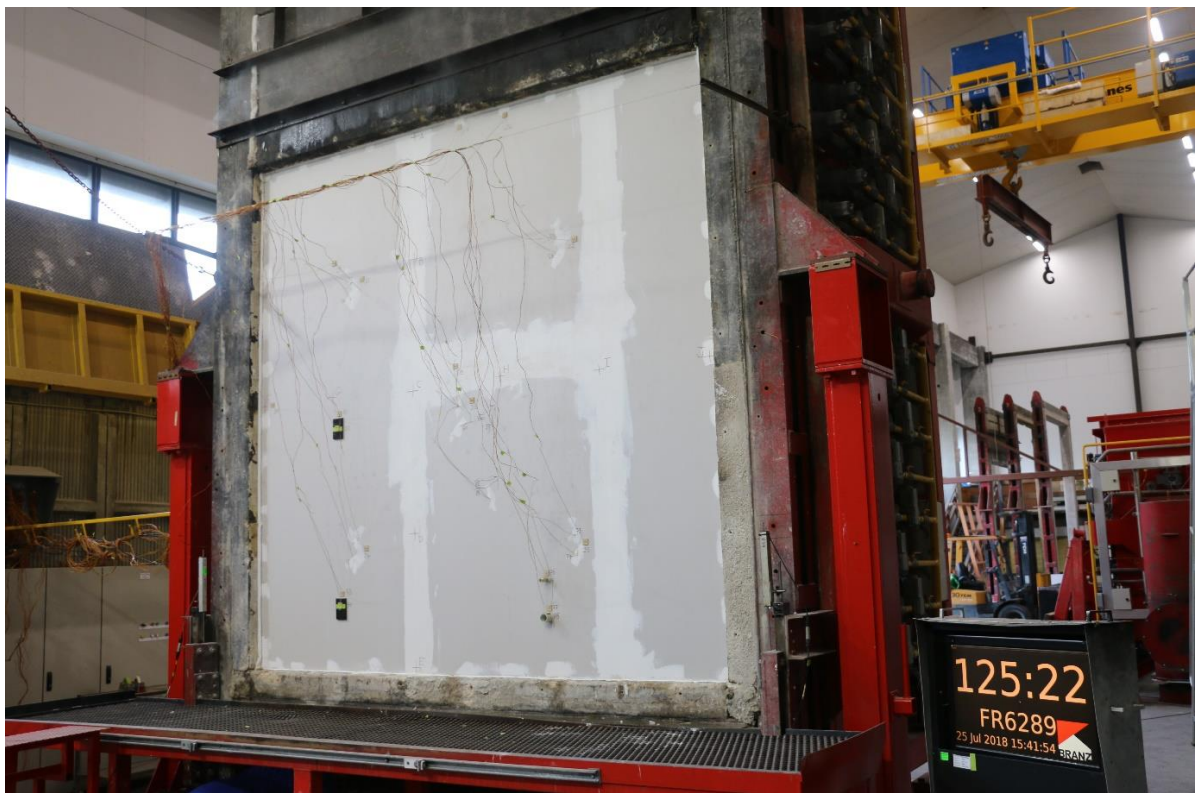
Photo 4: The Unexposed Face of the Wall After 125 Minutes
