LABORATORY MEASUREMENT OF AIRBORNE SOUND INSULATION OF A FLOORING SYSTEM (According to ISO 10140-2)

Report prepared for:
Resene Construction Systems Ltd
PO Box 58317
Botany
Manakau 2163
Auckland
Date: 28th October 2016

**LABORATORY
MEASUREMENT TONGUE
AND GROOVE FLOORING
SYSTEM**

**Sound reduction index, R, in accordance with ISO 10140-2
Laboratory measurements of airborne sound insulation of building elements**

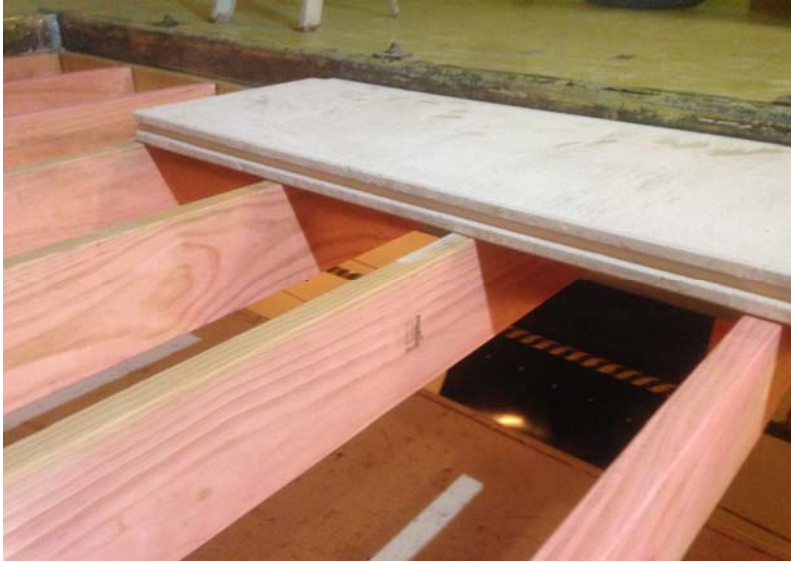
Test Floor Frame: 190mm x 45mm timber joists set at 450mm centres

Test Floor Linings: Source chamber side: Rockcote Resene Integra tongue and groove flooring panels screw-fixed to the timber joists.

Figure 1: Placing the Rockcote panels on the timber joists

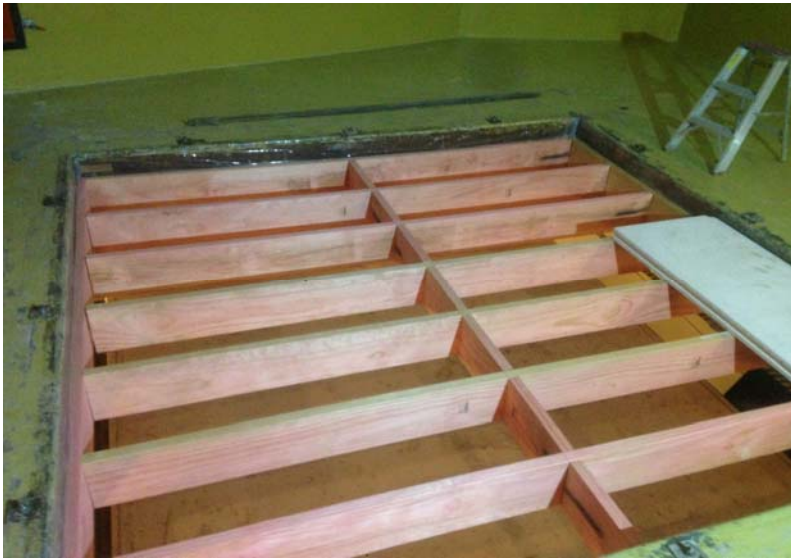
Figure 2: Floor framing showing the central joist nogs

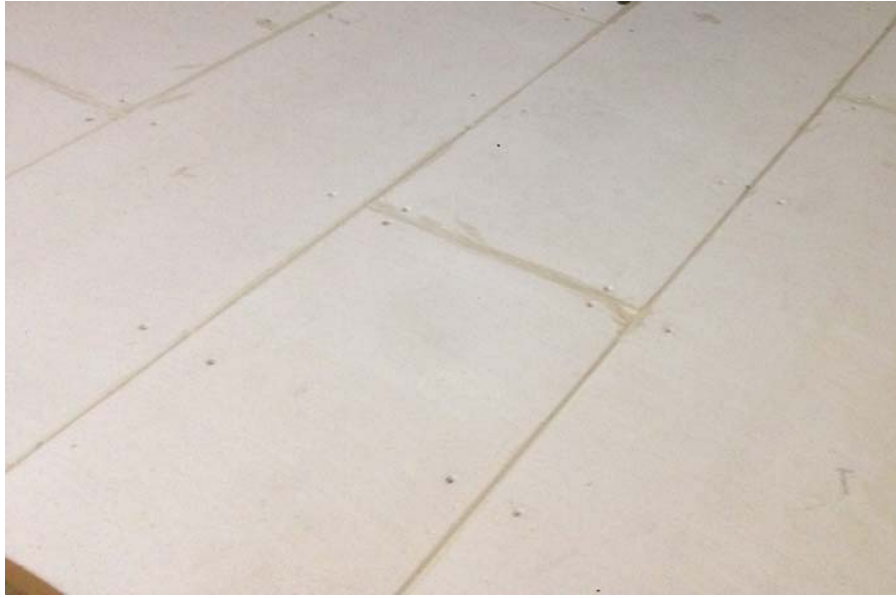
Test Floor Lining Joint Filler: GIB Soundseal

Test Floor Perimeter Sealant: GIB Soundseal

Figure 3: Rockcote floor surface showing screw-fixings and sealant in joints

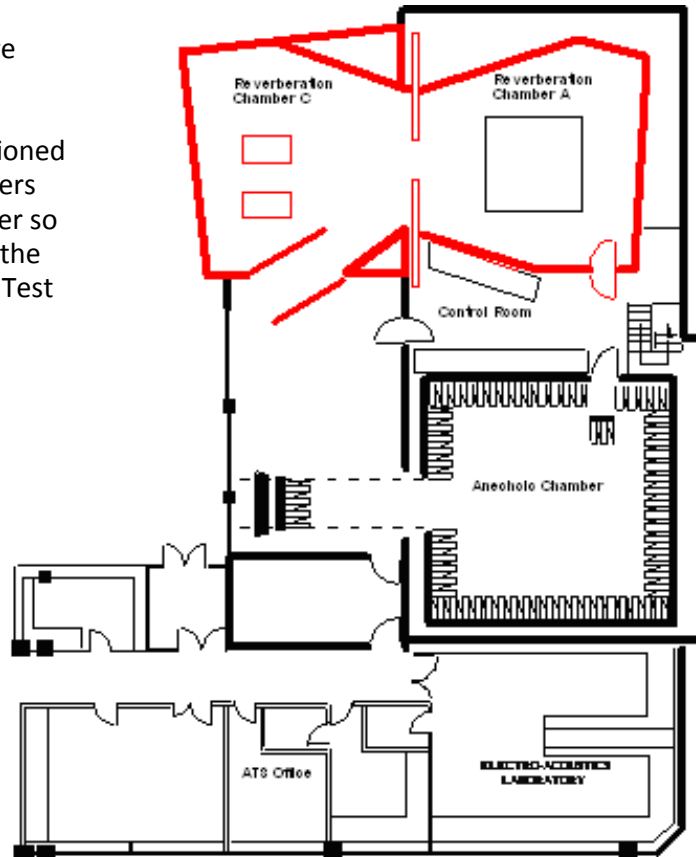
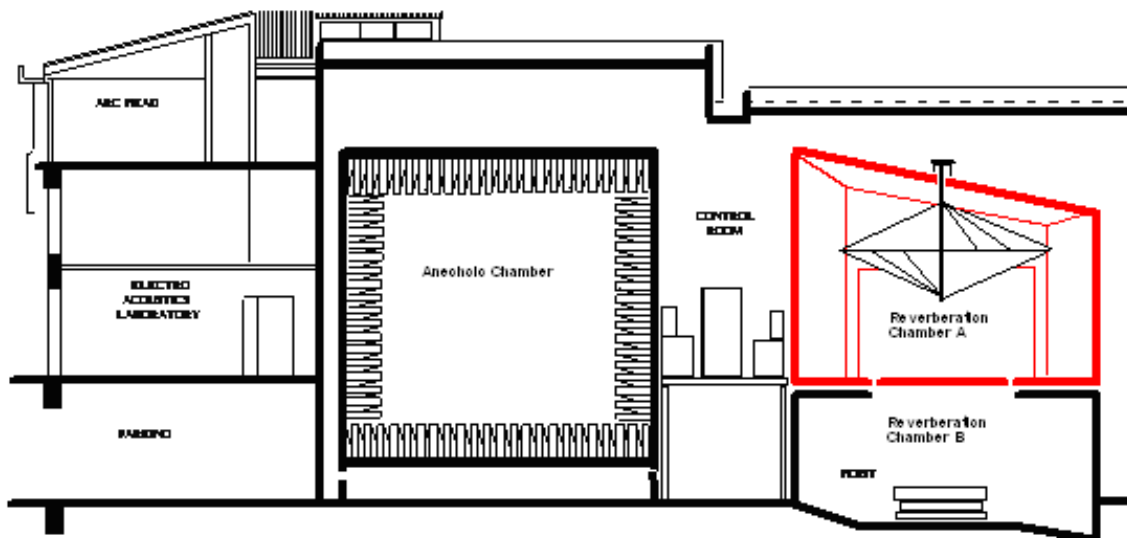
The three Reverberation Chambers are linked by heavy steel doors and a removable Standard Industrial Floor Section which is removed and repositioned by a hydraulic hoist. The three chambers are vibration isolated from one another so that sound can only pass from one to the other via the intervening Test Wall or Test Floor/Ceiling Section

VOLUME (m ³)	SURFACE AREA (m ²)
Chamber A	202 ± 3	203.6 ± 0.9
Chamber B	153 ± 2	173 ± 1
Chamber C	209 ± 4	214 ± 0.9
