# Laboratory measurement of airborne insulation of a wall system

Test report ID: T1830-1

# LABORATORY MEASUREMENT OF AIRBORNE AND IMPACT INSULATION OF BUILDING ELEMENTS ACCORDING TO ISO-10140

**Airborne sound insulation of a wall system**

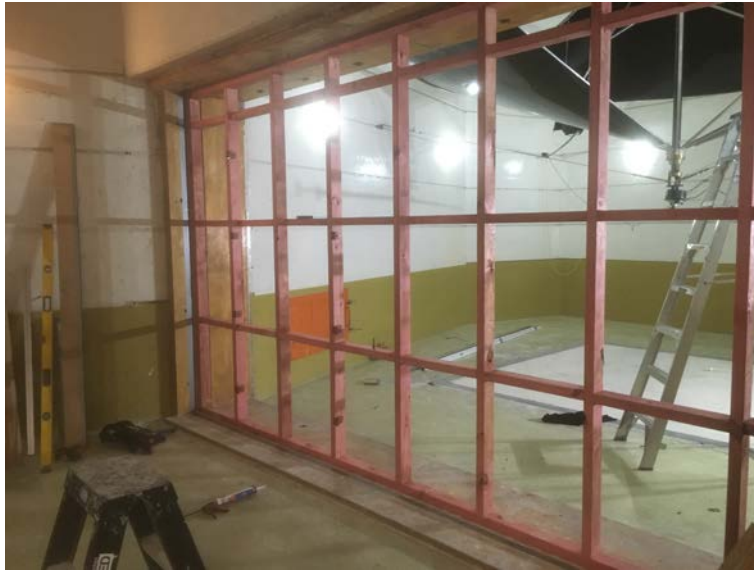
Figure 1.1: 90x45mm studs and nogs

Framing: 90 mm x 45 mm timber frame with studs set at 600 mm centres and nogs set at 800 mm centres

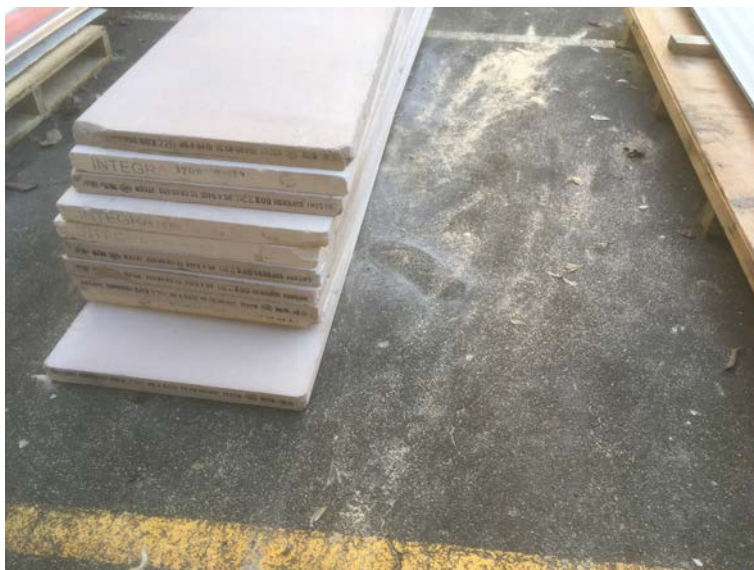
Figure 1.2: Wall panels

50 mm thick Integra panels adhered together at the joints

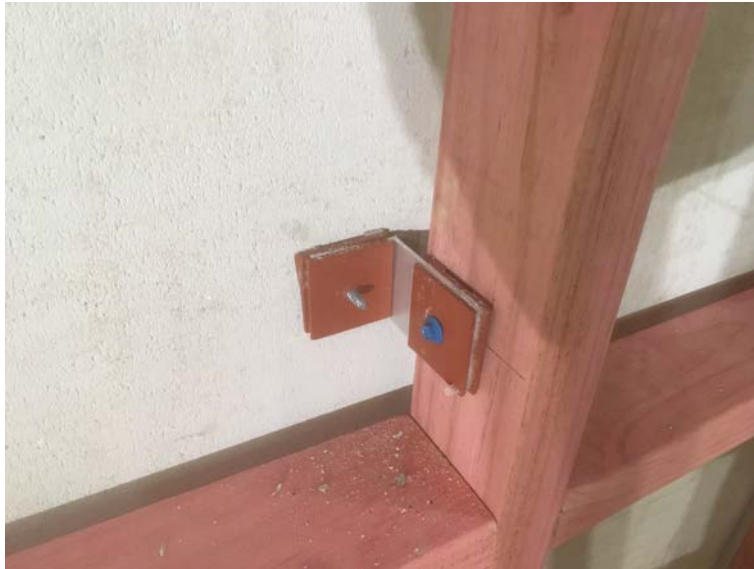
Figure 1.3: Panels fastened to studs

20 mm gap with rubber isolated L-brackets joining timber framing to Integra panels at 0.6 m vertical & 1.2 m horizontal centres

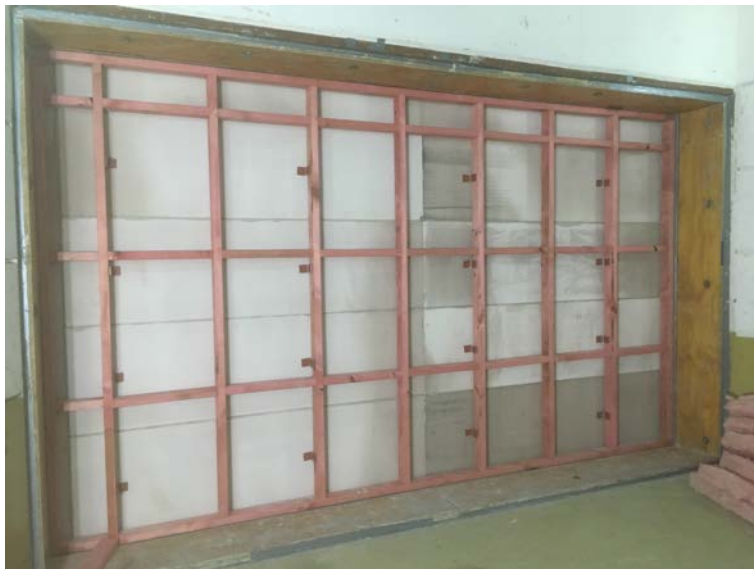
Figure 1.4: Panels installed over the wall

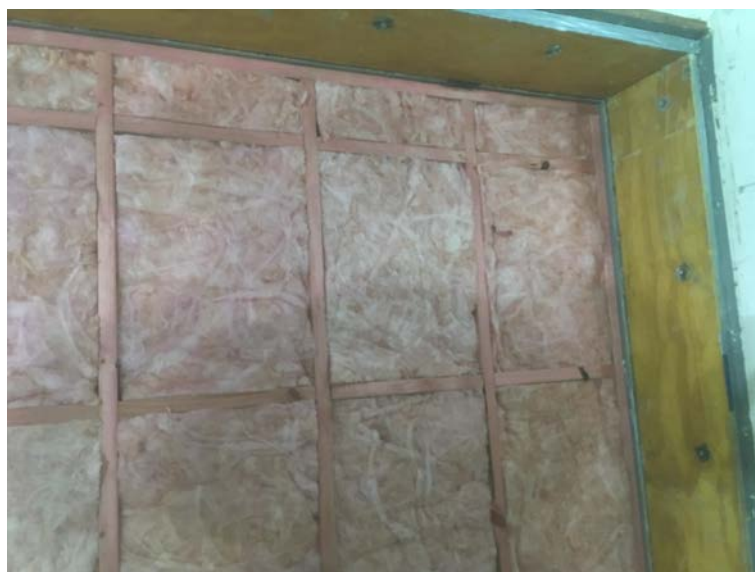
Figure 1.5: Thermal insulation material installed

Insulation: Pink Batts R2.2
